# Examples of recent rockfalls from basalt cliffs in Northern Ireland

**Peter Wilson and Alana Cunningham**

*School of Environmental Sciences, University of Ulster at Coleraine*

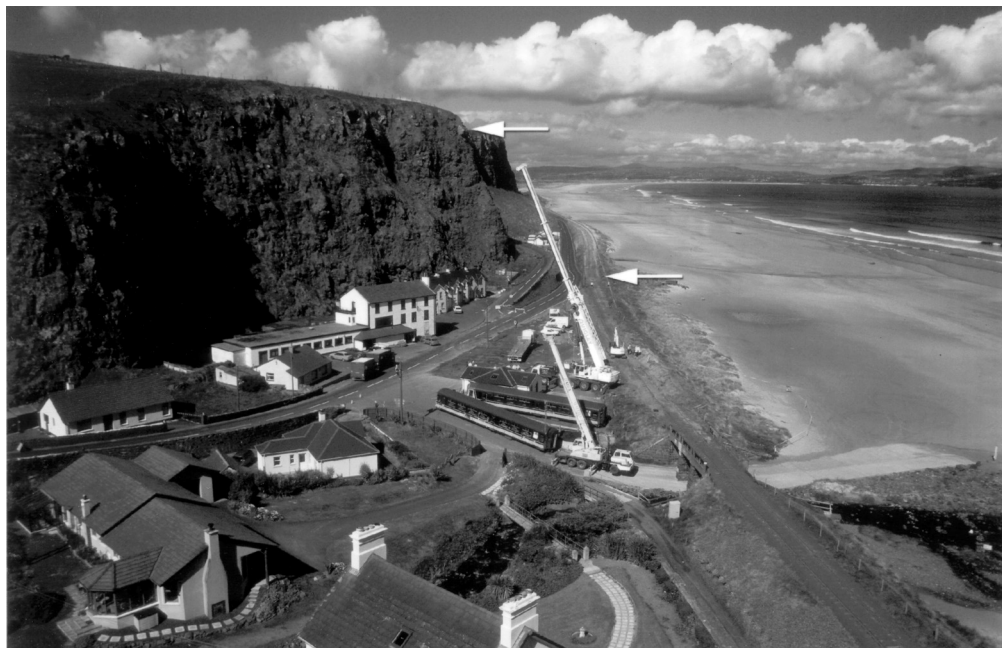
Figure 2: View of the derailment site from the east showing the relationship between cliff, roads and railway. The upper arrow indicates the rockfall site, the lower arrow marks where the train hit the boulder.

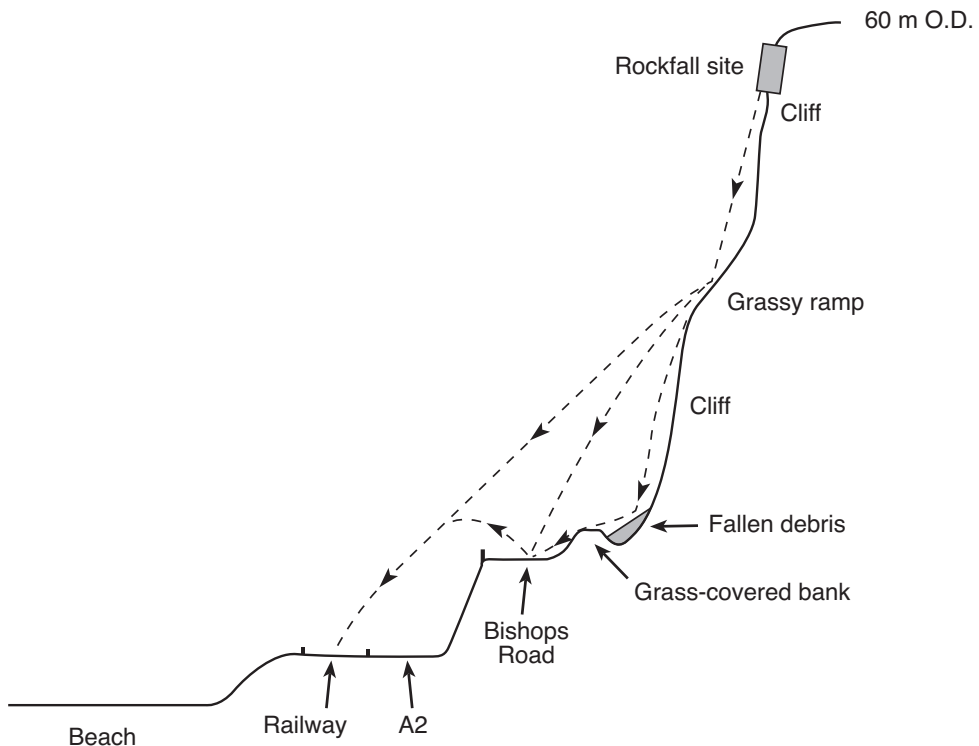
Figure 3: Pathways of debris movement at Downhill. Not to scale.

with considerable force. The largest of these depressions was 12x7x5 cm. At least one boulder, of unknown size, either hit the ramp and then the Bishops Road with sufficient force that it bounced over the A2 and ended up on the railway line or, after hitting the ramp, the trajectory of the boulder carried it across both the Bishops Road and the A2 onto the railway line (Figure 3).

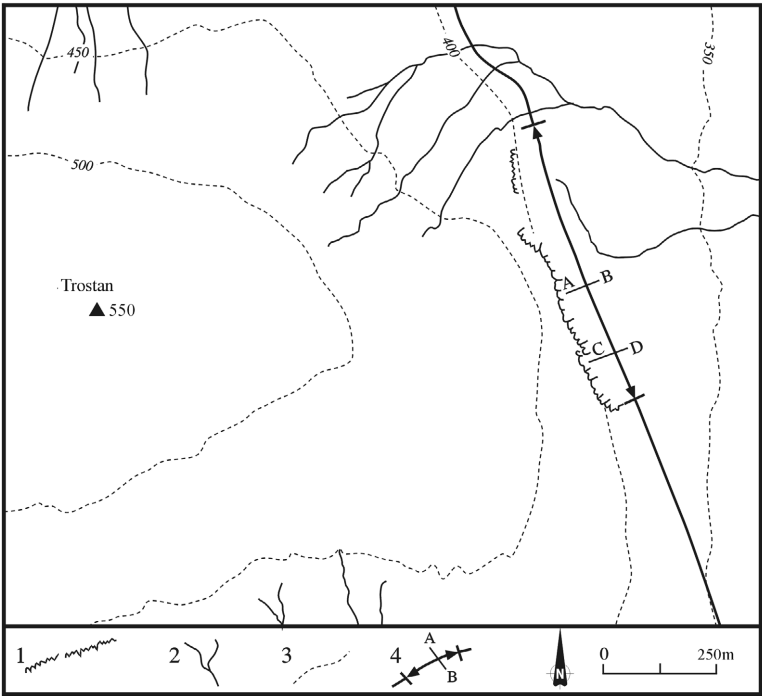
For a distance of c. 650m on the east side of Trostan the line of the former railway is overlooked by basalt cliffs (Figure 4), and the track bed and adjacent hillslopes are partly covered by basalt boulders (Figure 5). It is clear that the boulders on the line of the former

Figure 4: Line of former railway and rockfall site on east side of Trostan, co. Antrim. Location of Trostan in Northern Ireland is shown on Figure 1 inset. 1, cliffs; 2, watercourses; 3, contours in metres; 4, former railway with profile locations and zone with track bed boulders indicated.

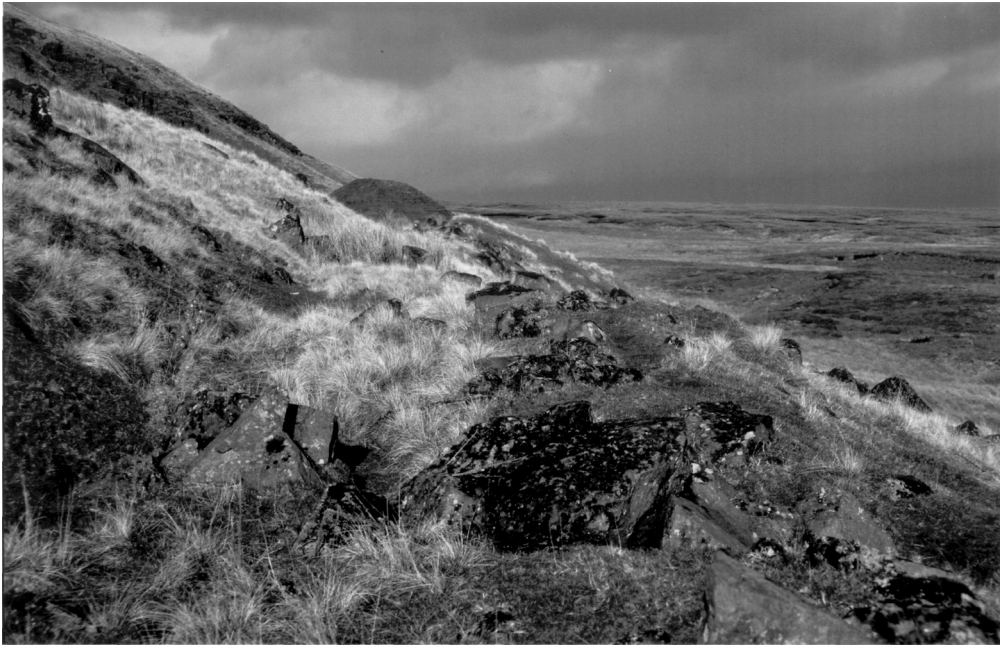
Figure 5: Basalt boulders on the track bed of the former railway.

railway post-date removal of the track and therefore represent the products of rockfall events during the twentieth century. The boulders on hillslopes adjacent to the track bed are likely to be of the same age.

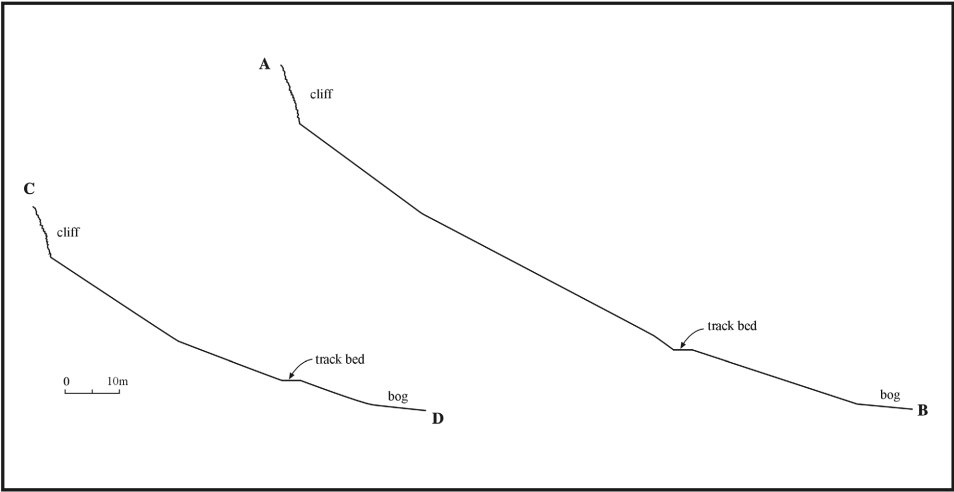
Figure 6: Surveyed profiles across the track bed and adjacent hillslopes. Profile locations are shown on Figure 4.

Two profiles surveyed across the hillslopes and track bed to the base of the cliffs (Figure 4) indicate the form and relationships of these morphological components (Figure 6). Downslope of the track bed, hillslope gradients are 14–19°; those upslope are within the range 20–36°. The vertical drop from cliff base to track bed is 22–41 m. The cliffs above both profiles occur as tiers separated by steep grassy slopes. On profile A-B the lowermost cliff tier is 10 m high and on profile C-D it is 15–20 m high.

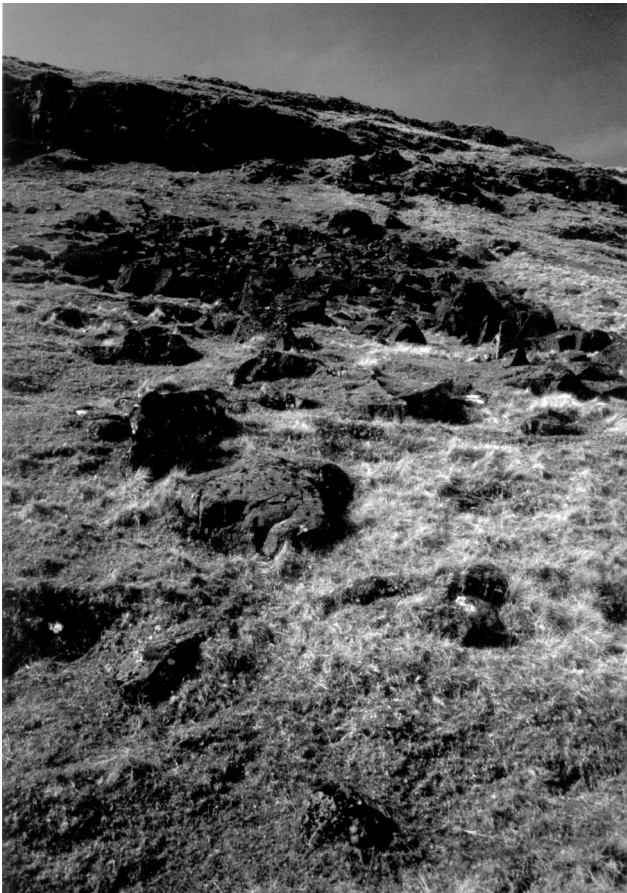
Figure 7: Debris from cliff collapse on hillslope above track bed of former railway.

The largest boulder on the track bed measures 1.8 m x 1.7 m x 1 m. This occurs immediately north of profile A-B and is part of the debris of a substantial cliff collapse (Figure 7). Maximum boulder size in the debris above the track bed is 4.9 m x 2.5 m x 2 m and below the track bed the largest boulder is 3.5 m x 3 m x 1.8 m. Numerous boulders have a *b* axis in excess of 1 m.
